SCS ENGINEERS

February 17, 2016
File No. 25211357.33

Subject: Dike Inspection - Petersburg Generating Station Ash Pond Facilities
2015-2, November 12, 2015

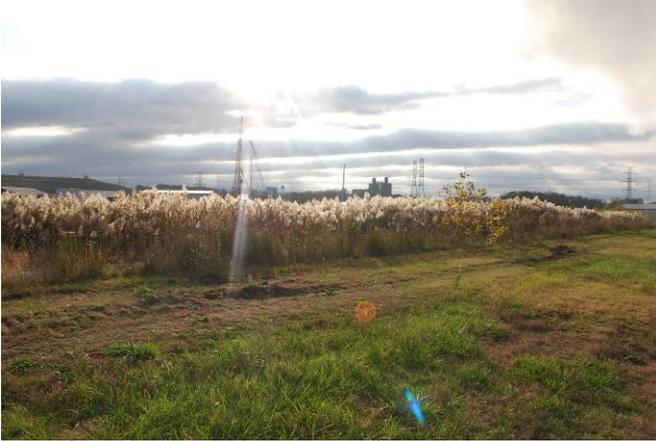
Photo 1: Downstream slope of Pond A, looking south.

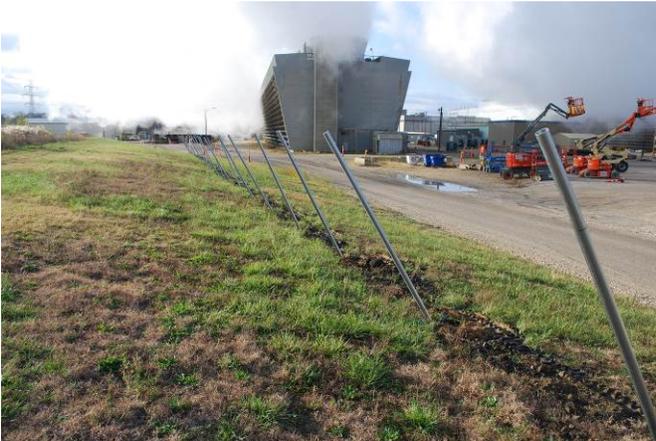
Photo 2: Same as Photo 1, looking southwest.

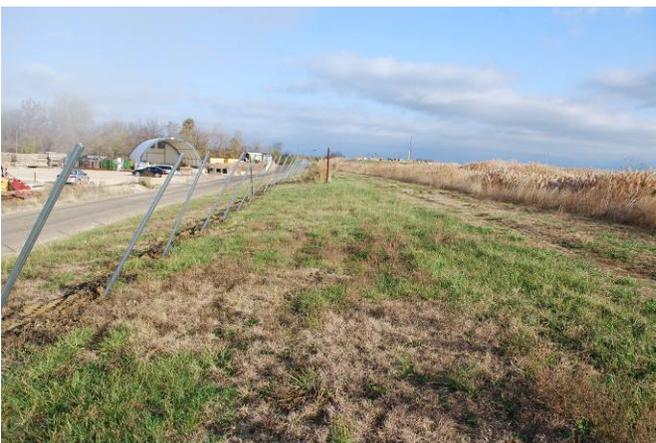
Photo 3: Same as Photo 1, looking north.

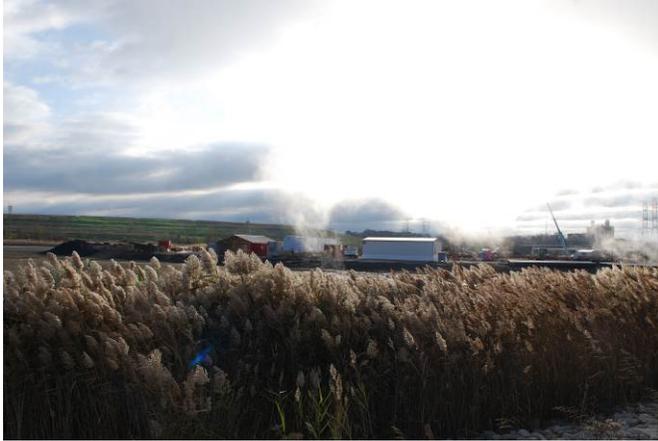
Photo 4: Looking southeast across Pond A.

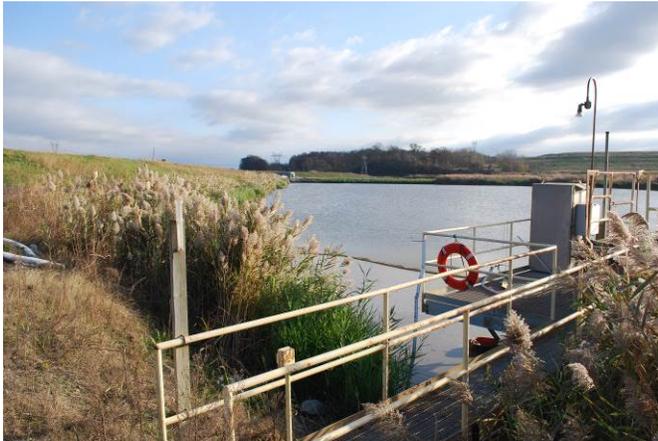
Photo 5: Pond A, looking east.

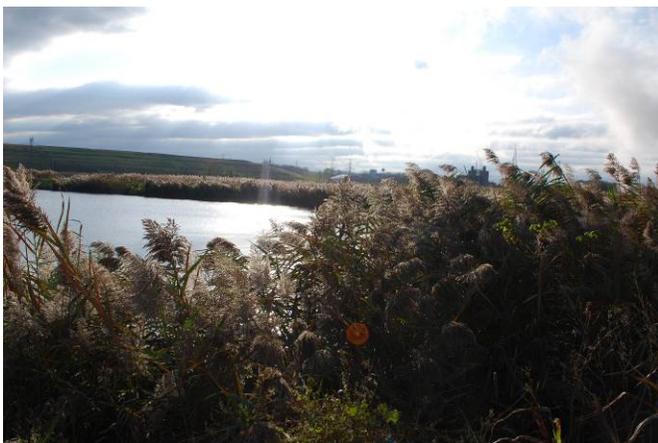
Photo 6: Pond A, looking south.

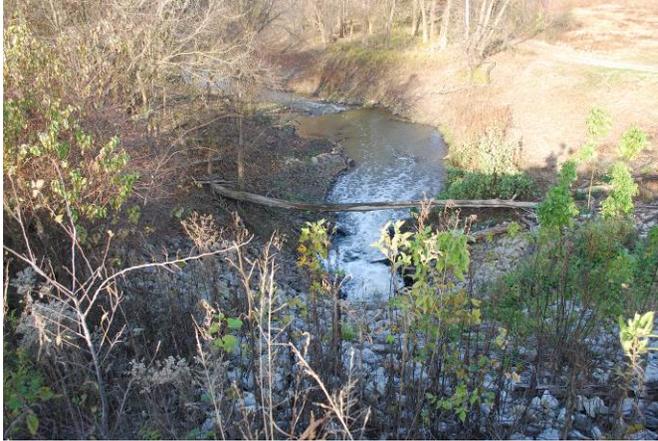
Photo 7: Discharge from Pond A into Lick Creek.

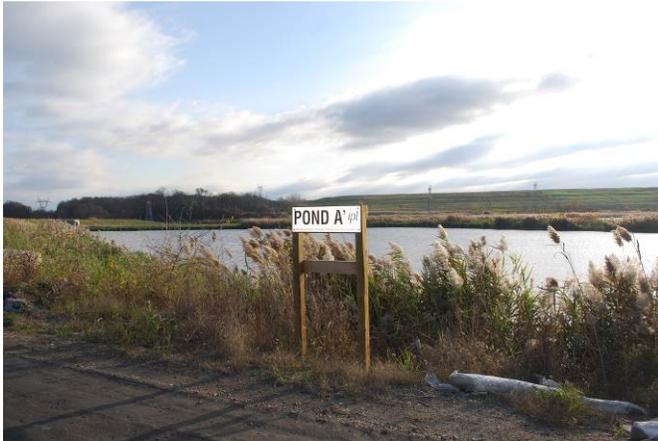
Photo 8: Pond A, looking southeast.

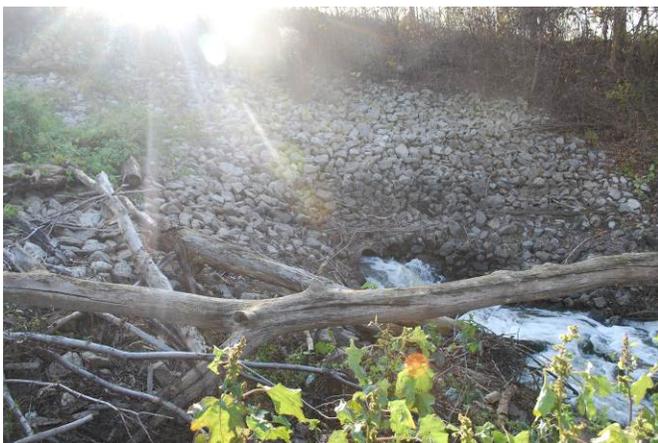
1. No significant problems were observed during the inspection.
2. Discharge pipe from Pond A Discharge to Lick Creek was visible at the time of this inspection. Rip-rap on the downstream slope of Pond A Discharge dike appeared stable. The exposed end of the discharge pipe appeared to be in good condition.

Photo 9: Pond A discharge into Lick Creek, looking southeast into the discharge pipe and rip-rap.

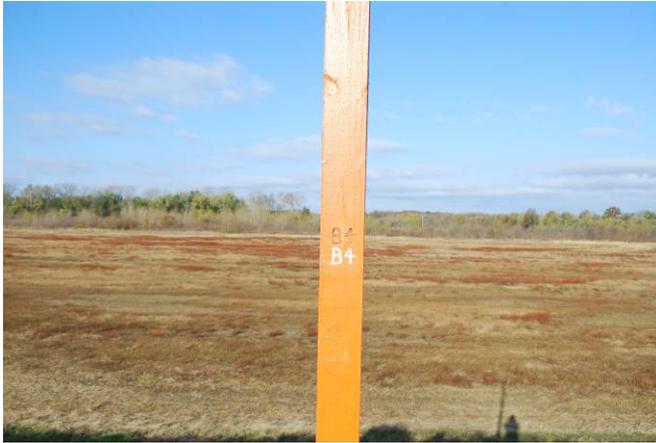
Photo 10: Marker for Piezometer B-4.

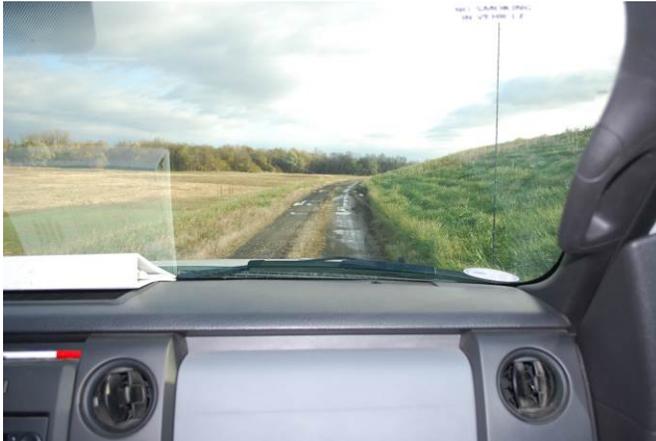
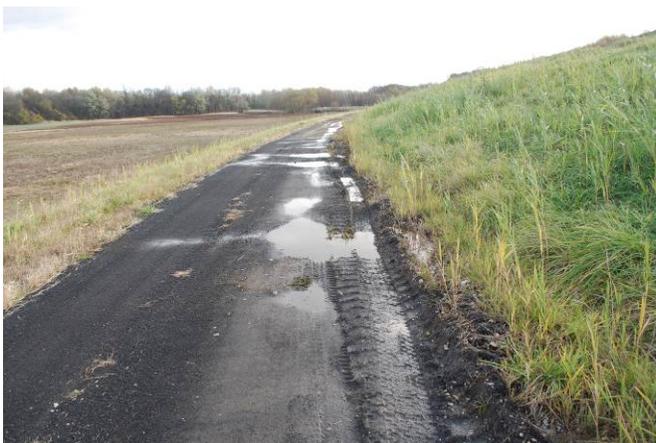
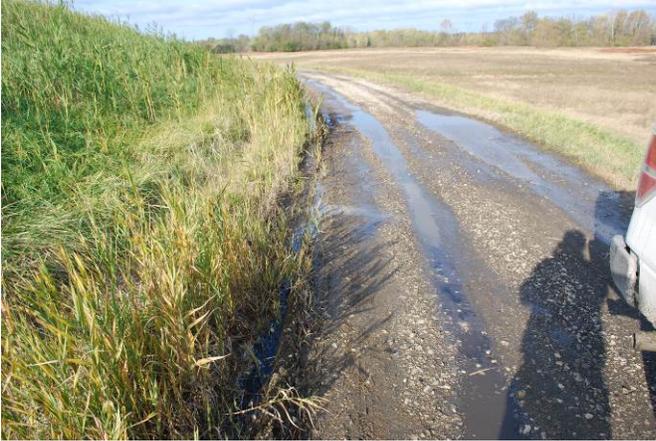
1. Pond C will still be used for processing ash slurry materials generated from the dredging activities in Pond A. In the future, the only ash materials that will be slurred to Pond A will be bottom ash, so the use of Pond C will be required on a significantly less-frequent basis.
2. IPL had completed the excavation of about 100,000 cubic yards of ash from Pond C.
3. There was seepage noted along the toe of the upper dike of Pond C, especially in the northeast corner of the pond. The water level in Pond C was relatively low since the completion of dredging activity.
4. Mr. Hendron did not observe the movement of fine materials from seepage occurring in the west and the northeast portions of the top dike of Pond C.

Photo 11: West slope of Pond C, looking north. Note seepage on the intermediate roadway.

Photo 12: Same as photo 11.

Photo 13: Same as Photo 12, looking southwest from the Northwest corner of Pond C.

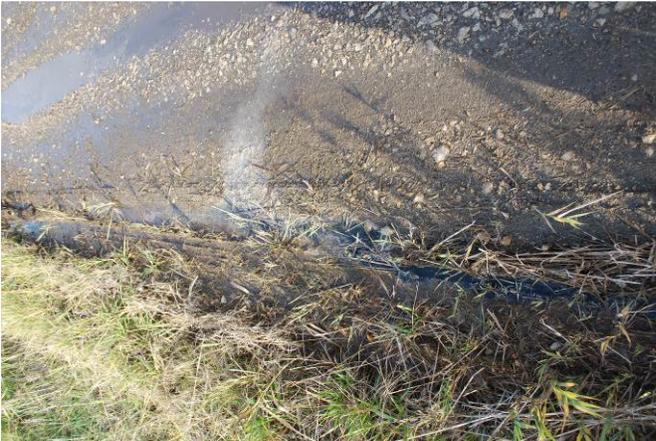
1. There were continuing visual signs of seepage occurring in the northeast corner of Pond C. The amount of seepage appeared to be somewhat greater than amounts observed during previous uses of Pond C. Additionally, there was substantial evidence of discoloration of the seepage fluids caused by the presence of fine material observed in the seepage occurring in this area of Pond C at the time of the inspection. We recommend close observation be continued to observe any changes to the nature and extent of seepage or movement of materials. IPL should notify Mr. Hendron immediately if changes are observed.

Photo 14: Close up of seepage showing white discoloration.

1. We recommend that daily inspections of the perimeter dike of Pond C be accomplished until the water accumulation from the last dredging of Pond A is eliminated and the visual signs of seepage and loss of fine material are also eliminated. If any visual changes in the seepage or movement of materials are detected, we recommend that IPL call Mr. Hendron immediately to discuss in detail.

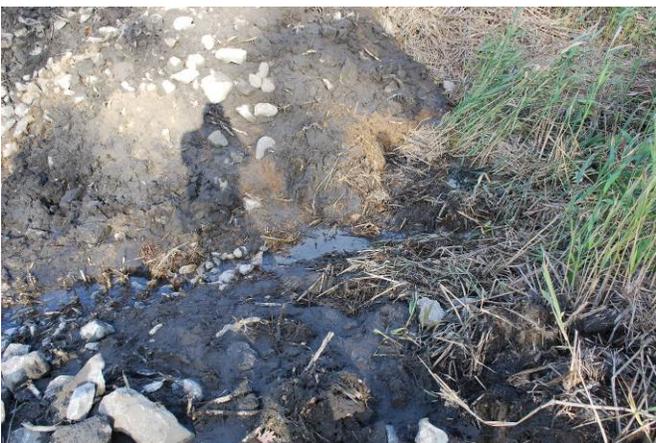
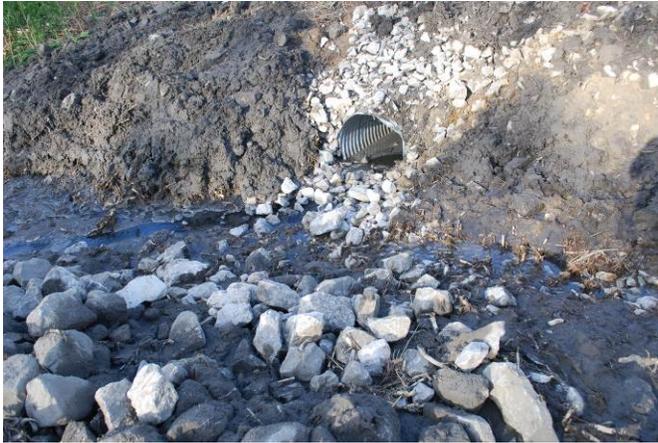
Photo 15: Flow in the ditch along the East perimeter dike of Pond C.

Photo 16: Same as photo 15.

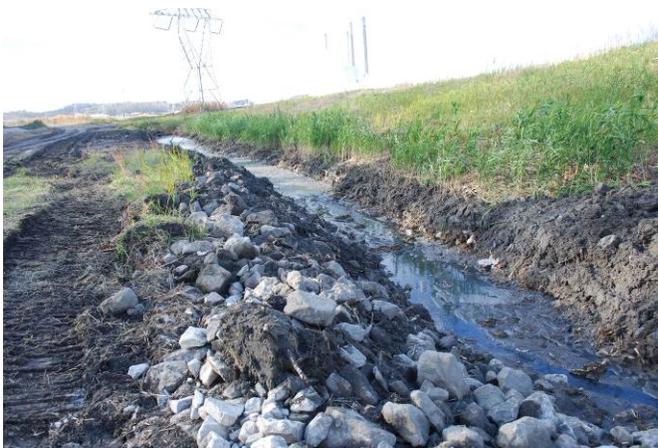
Photo 17: Excavation of the perimeter ditch along the East perimeter dike of Pond C, looking south.

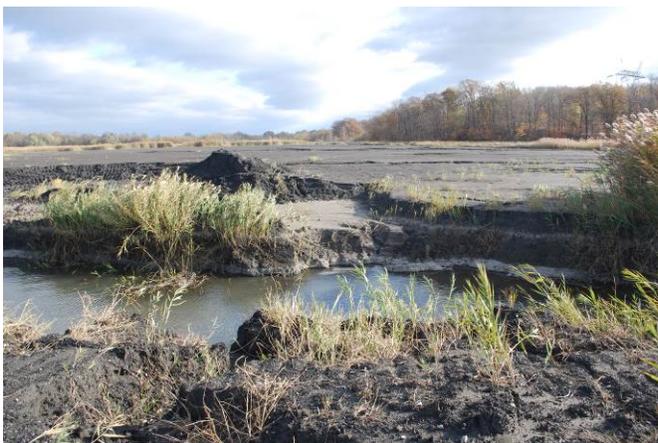
Photo 18: Pond C, looking north.

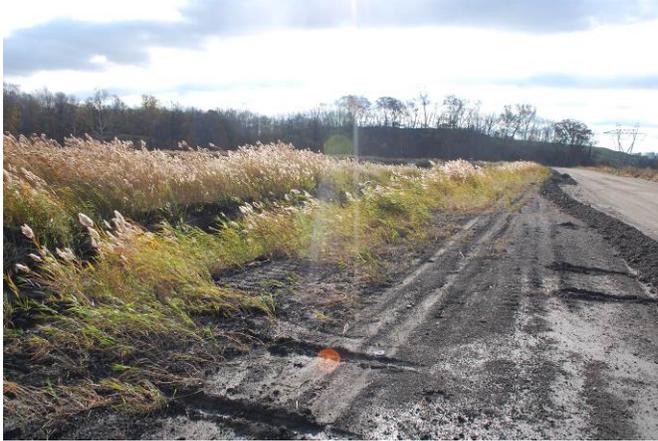
Photo 19: Pond C, looking east.

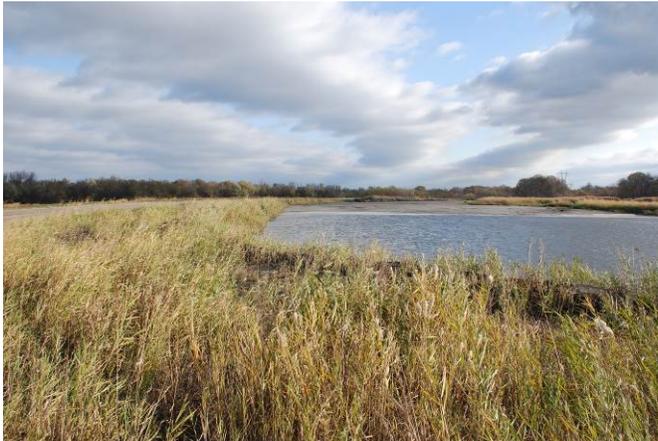
Photo 20: Surface water collecting in Pond C.

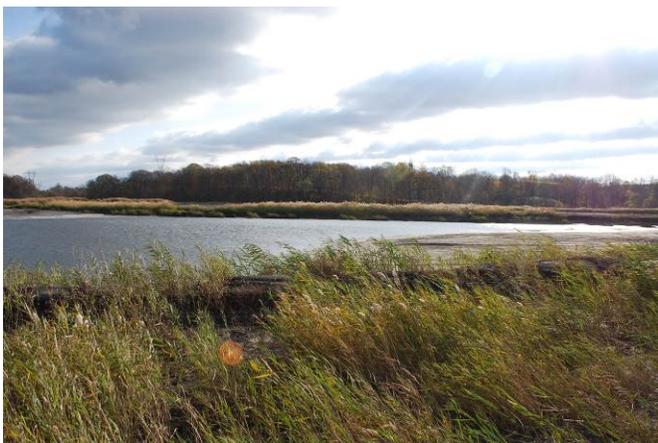
Photo 21: Surface water collecting in Pond C, looking northeast.

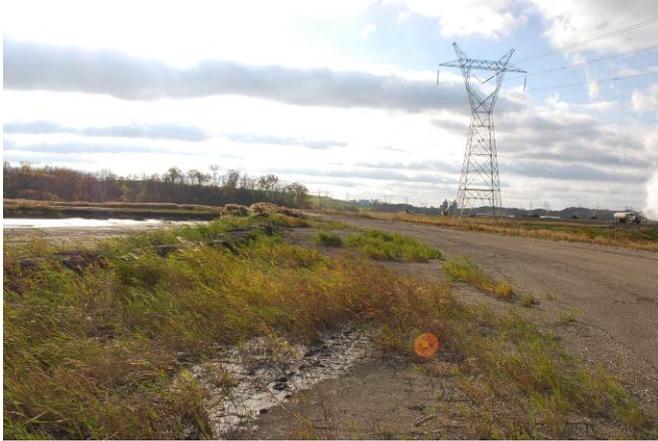
Photo 22: Pond C, looking east.

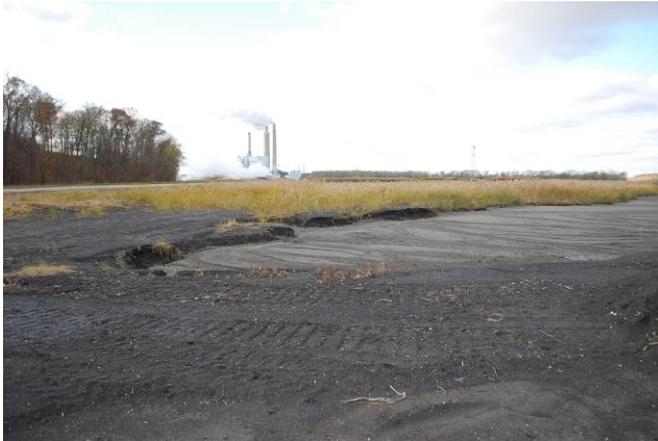
Photo 23: Pond C, looking south.

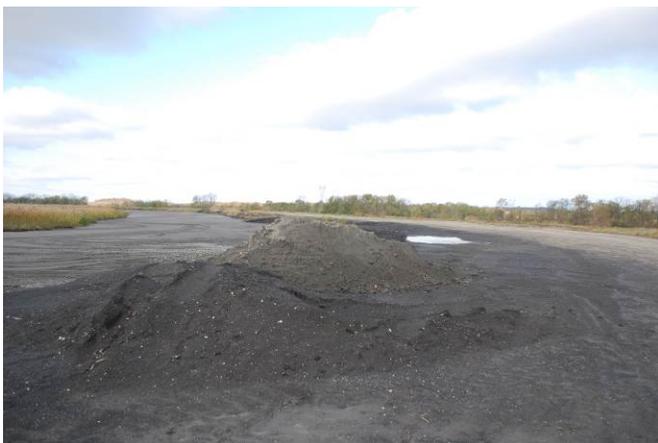
Photo 24: Pond C, looking southwest.

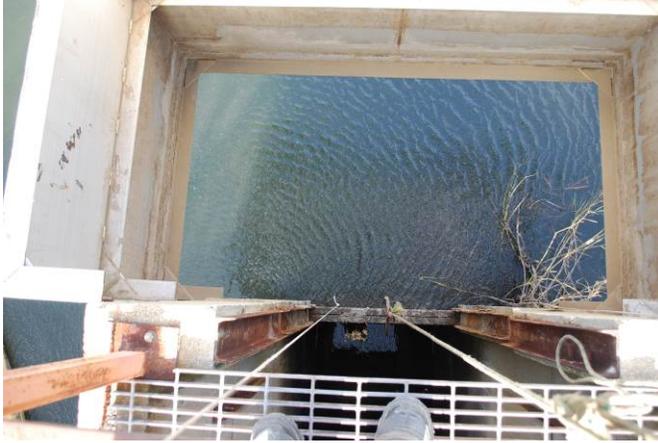
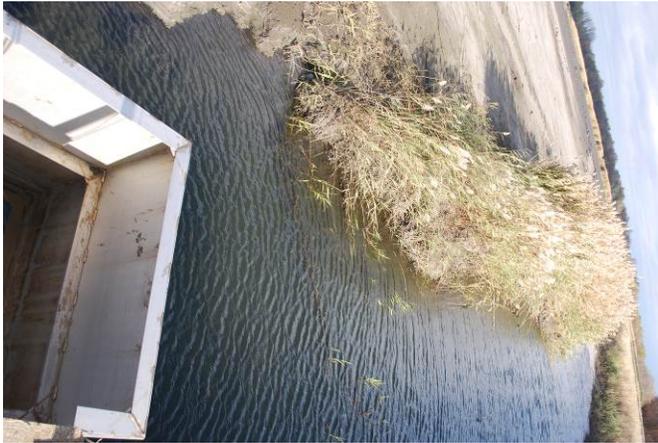
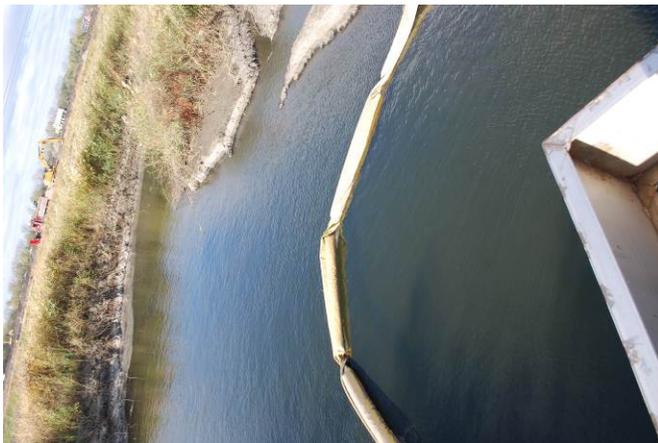
Photo 25: Water level in the discharge box from Pond C.

Photo 26: Same as Photo 25.

Photo 27: Same as Photo 25.

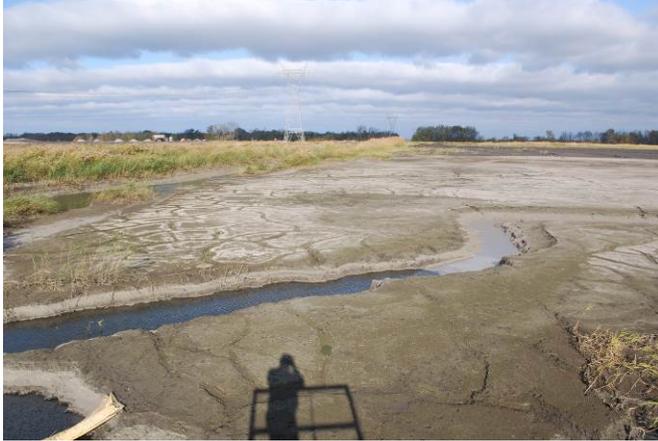
Photo 28: Pond C, looking west from discharge box of Pond C.

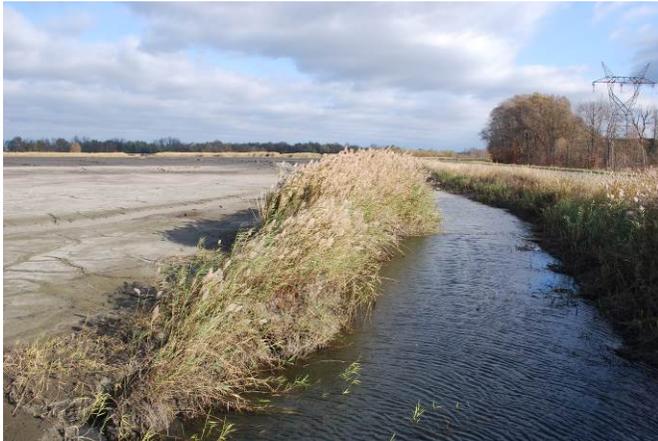
Photo 29: Same, looking north.
