REPORT ON
INITIAL PERIODIC STRUCTURAL STABILITY ASSESSMENT
POND 3A
J.M. STUART ELECTRIC GENERATING STATION
ABERDEEN, OHIO

by Haley & Aldrich, Inc.
Cleveland, Ohio

for Dayton Power & Light Company
Aberdeen, Ohio

File No. 40373-347
October 2016

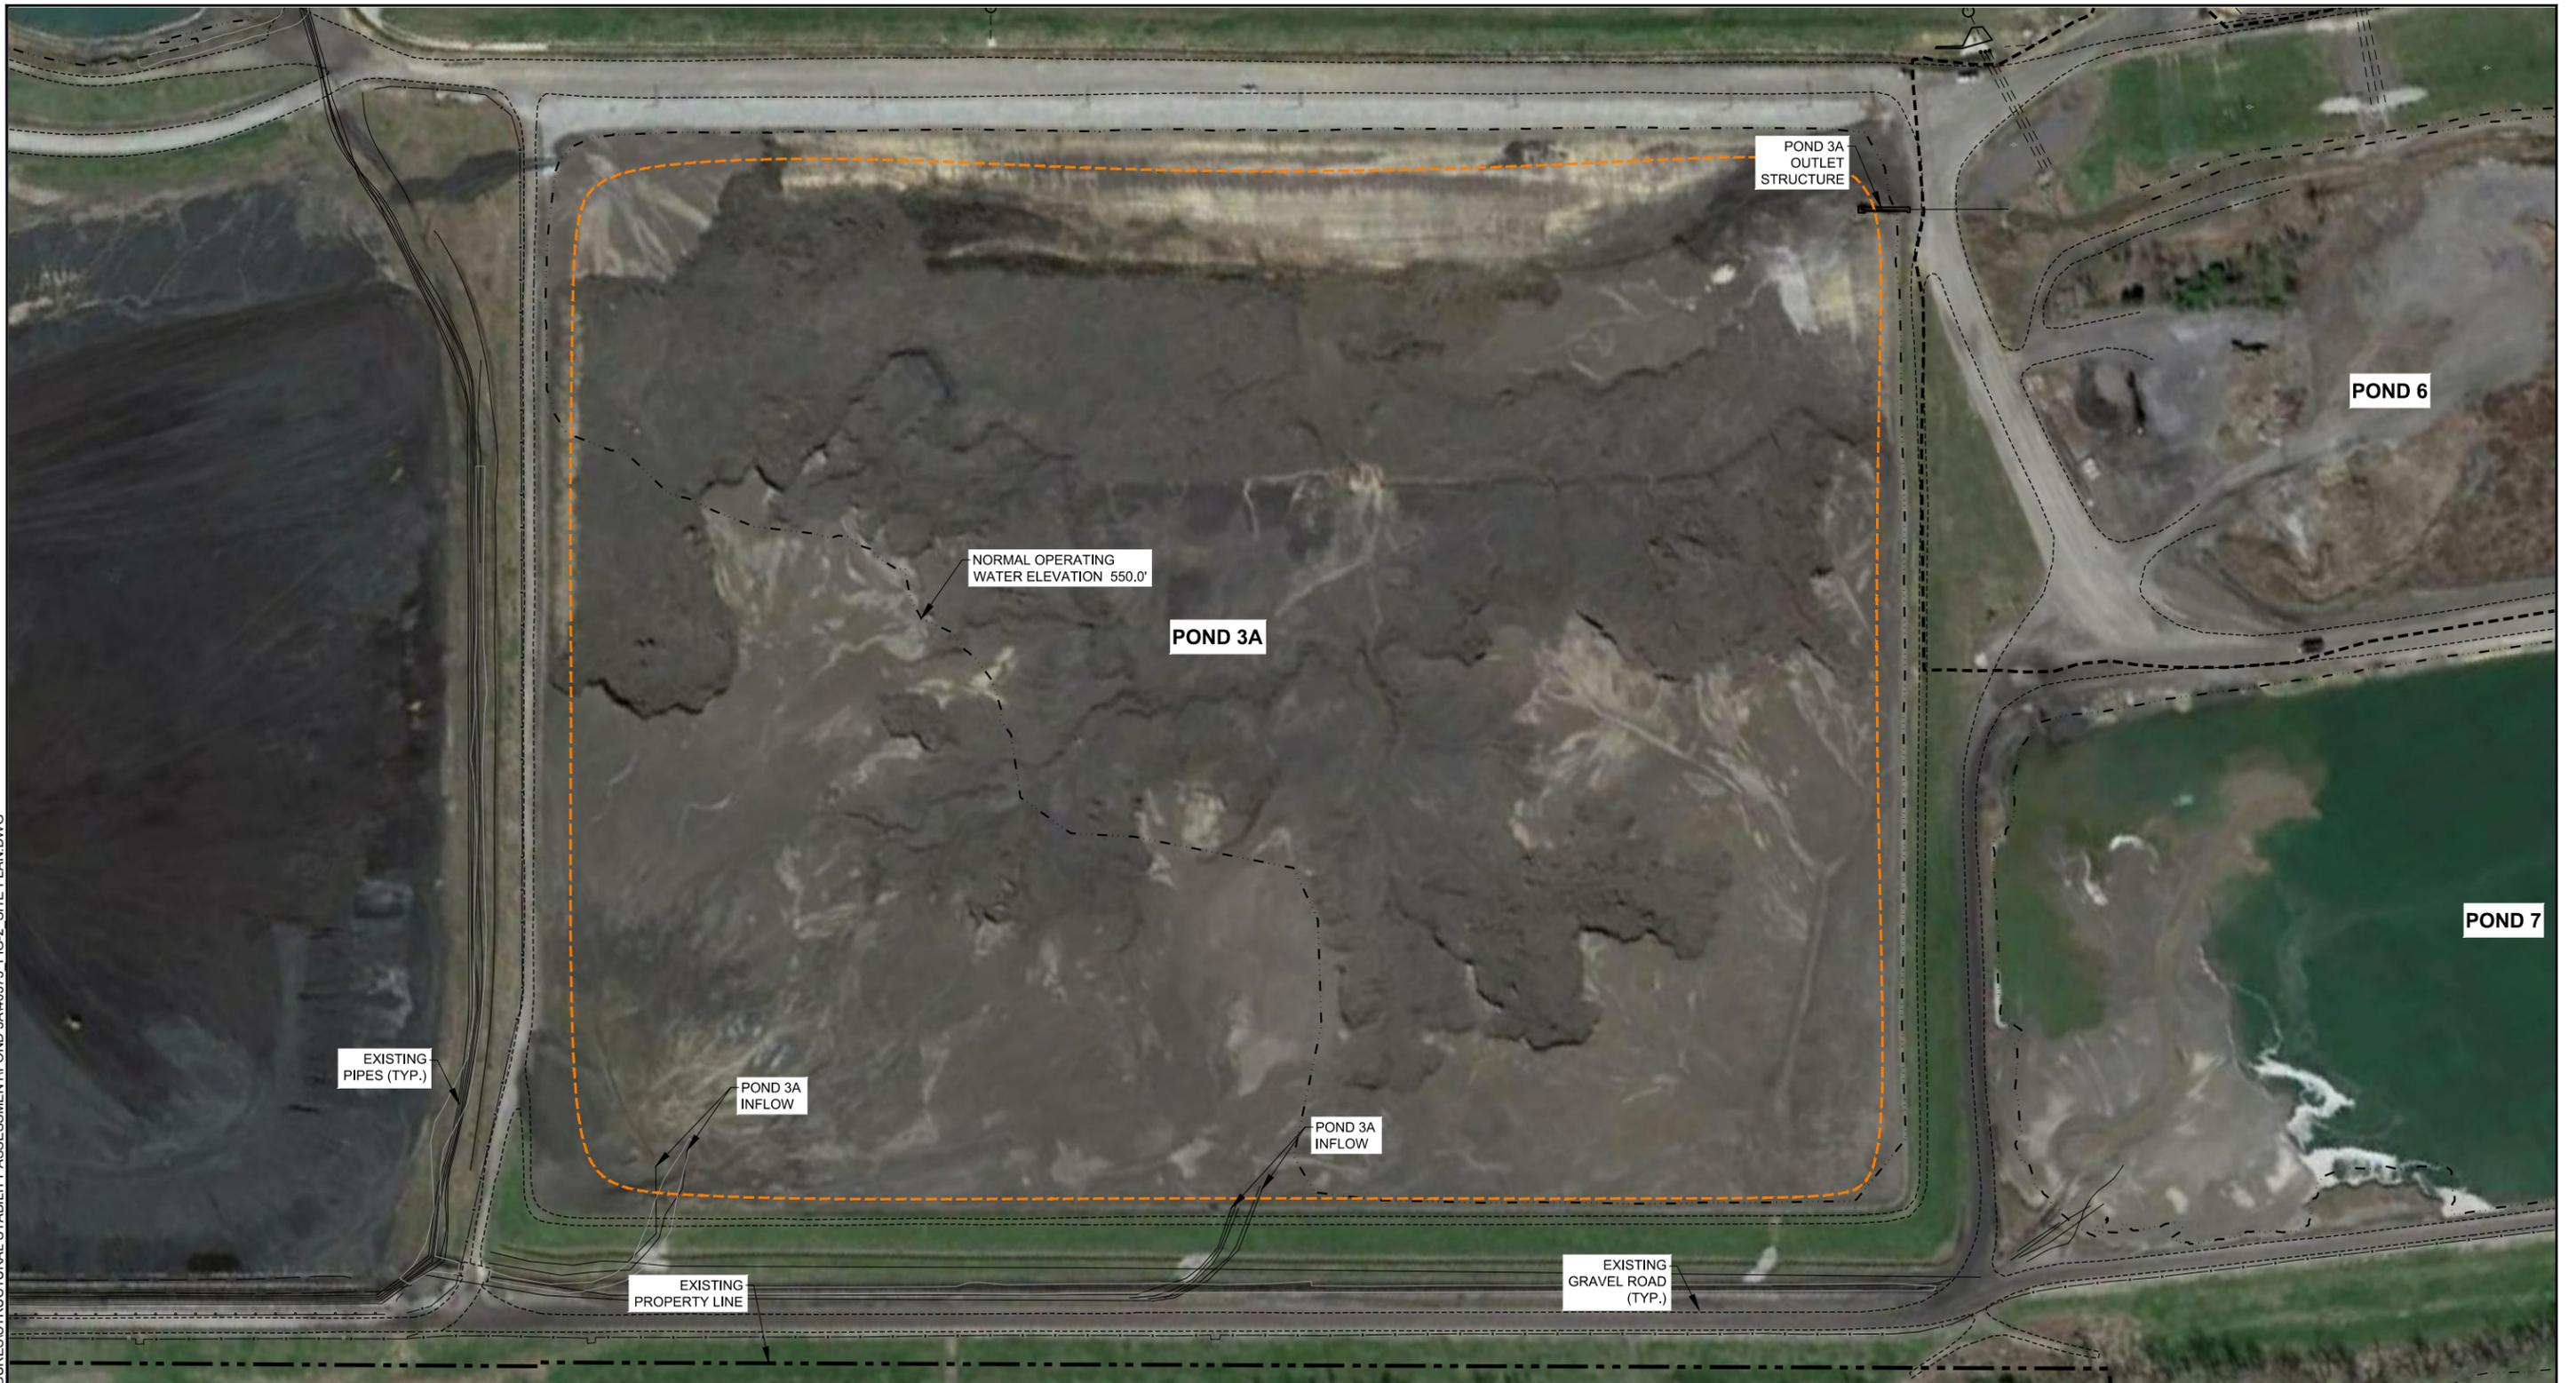
FIGURE 2

**POND 3A
SITE PLAN**
