MEMORANDUM

SUBJECT: CCR History of Construction
Pond 3A
Dayton Power & Light Company
J.M. Stuart Electric Generating Station
Aberdeen, Ohio

Haley & Aldrich, Inc. (Haley & Aldrich) has assisted Dayton Power & Light Company (DP&L) with compiling the history of construction for Pond 3A at the J.M. Stuart Electric Generating Station. This work was performed in accordance with the US Environmental Protection Agency's (EPA's) Hazardous and Solid Waste Management System; Disposal of Coal Combustion Residuals (CCR) from Electric Utilities, 40 CFR Part 257, specifically §257.73(c)(1).

Name of Unit: Pond 3A

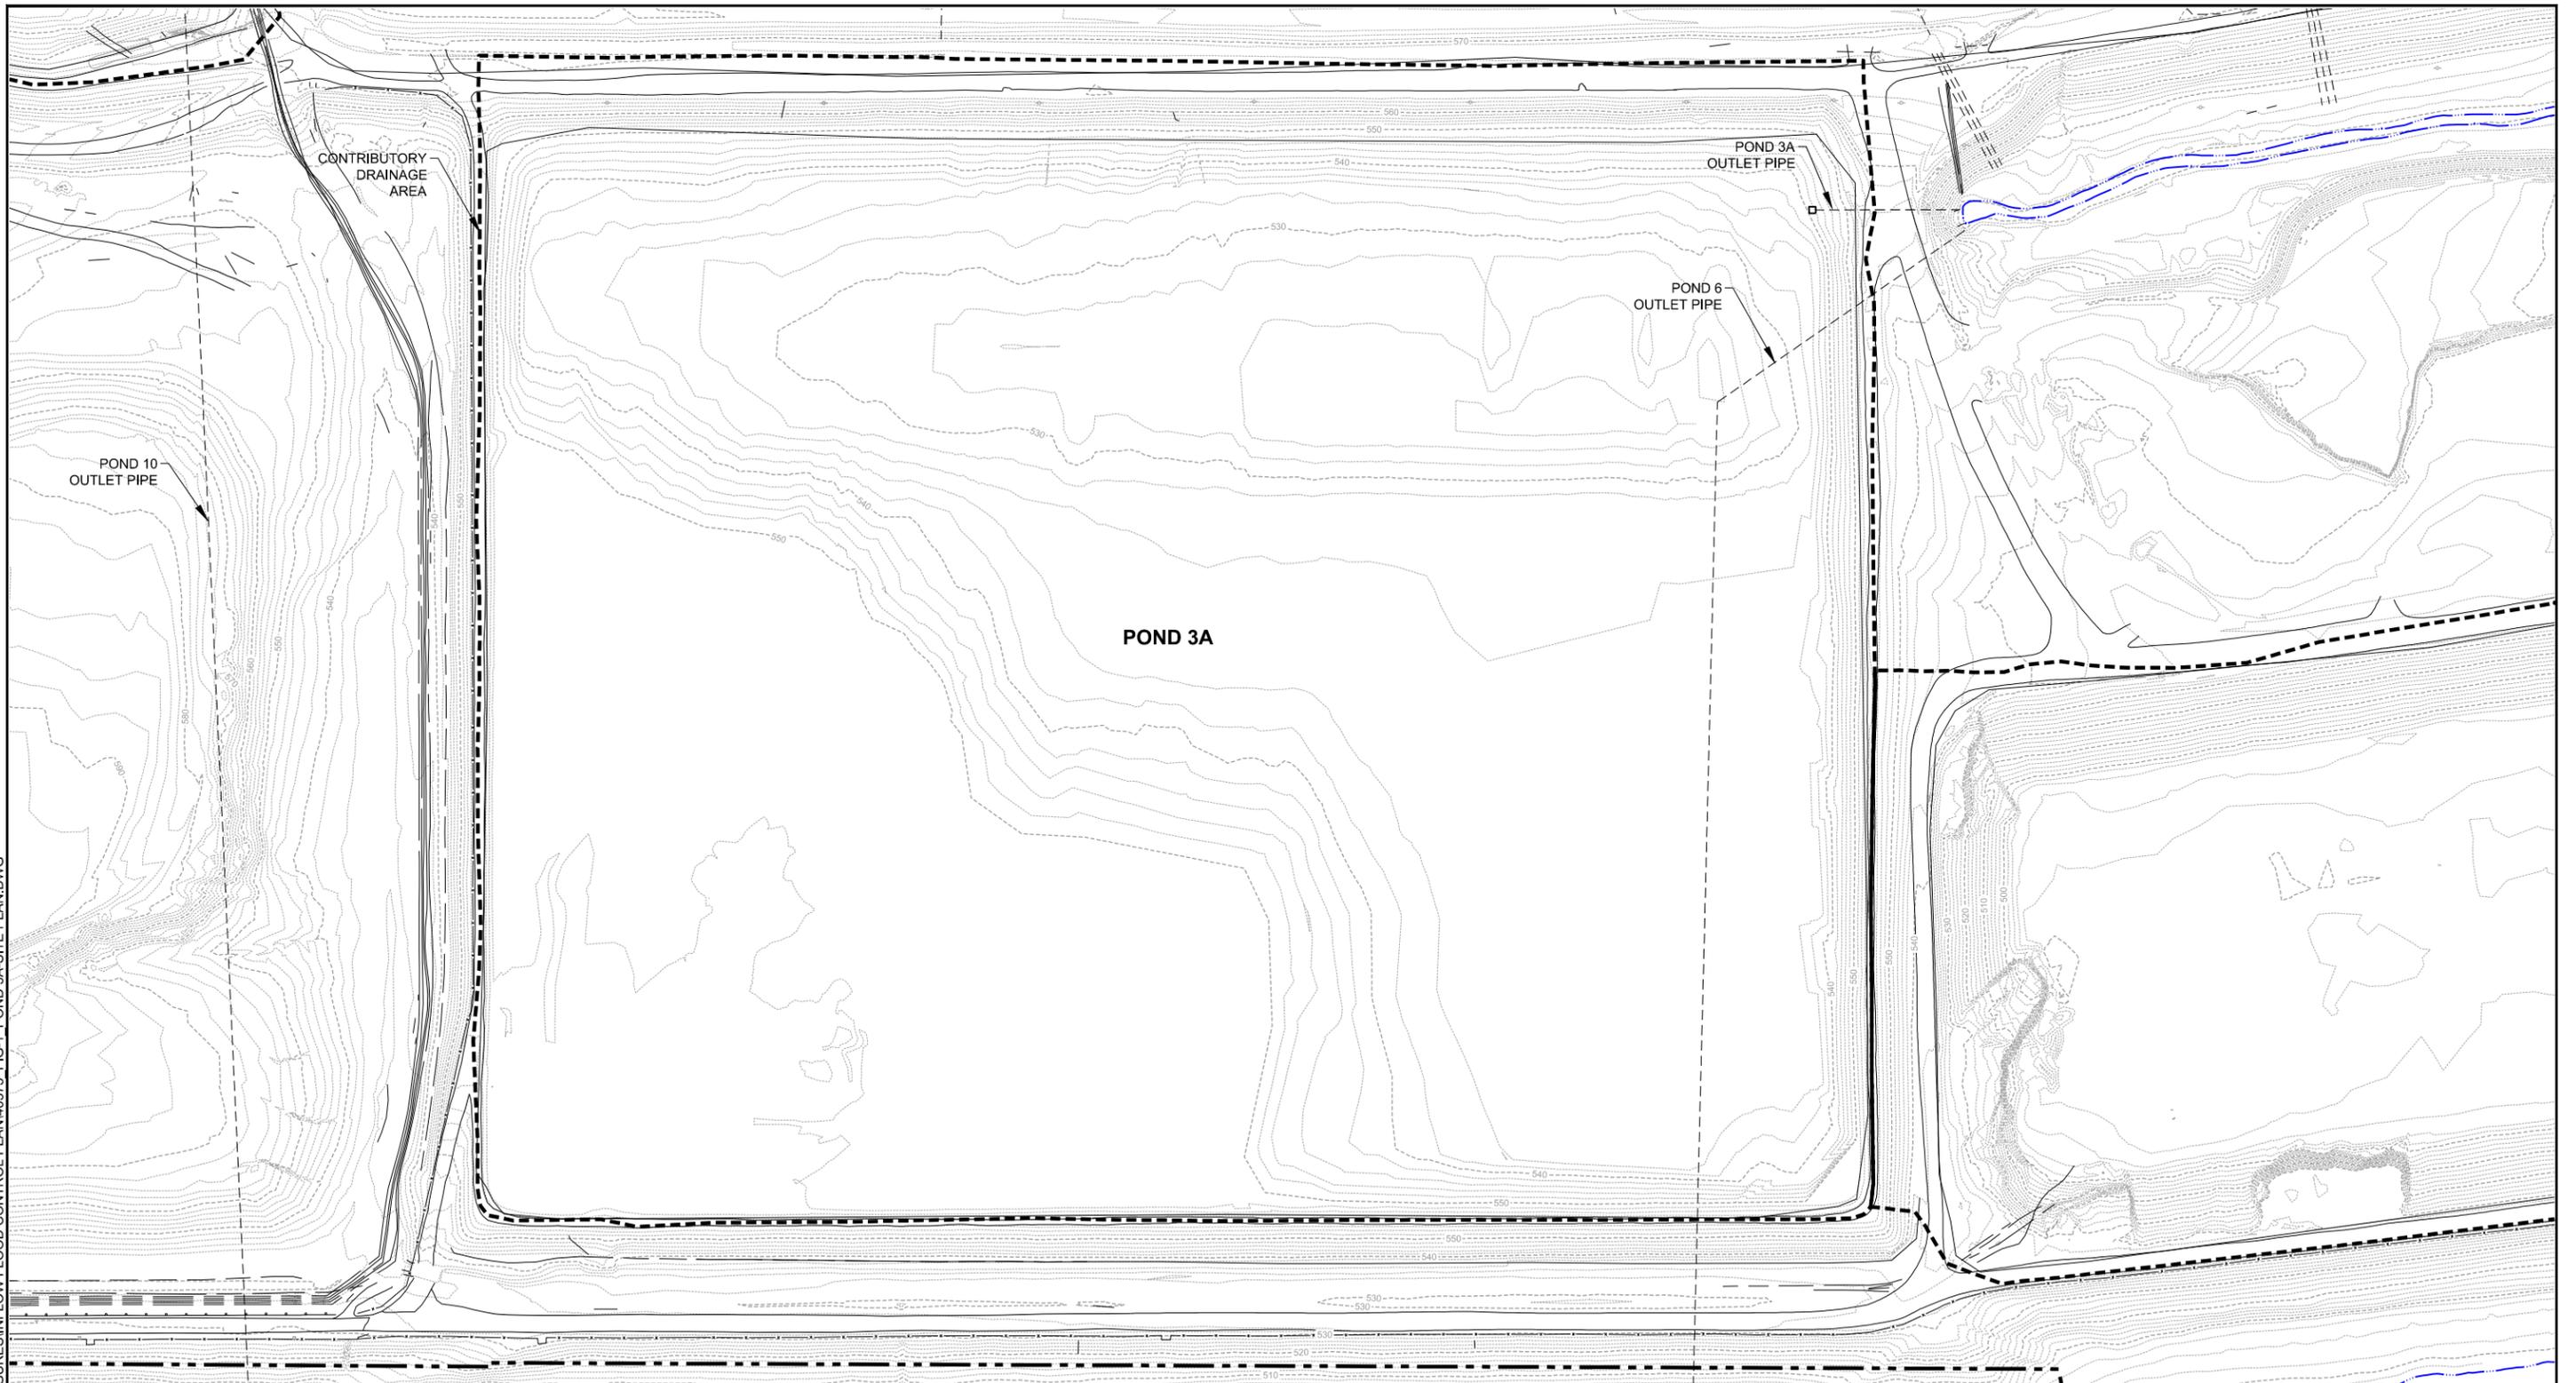
FIGURE 1

**Figure 1 and Appendix from:
Pond 3A Inflow Design Flood Control System Plan
By Haley & Aldrich, Dated October 2016**

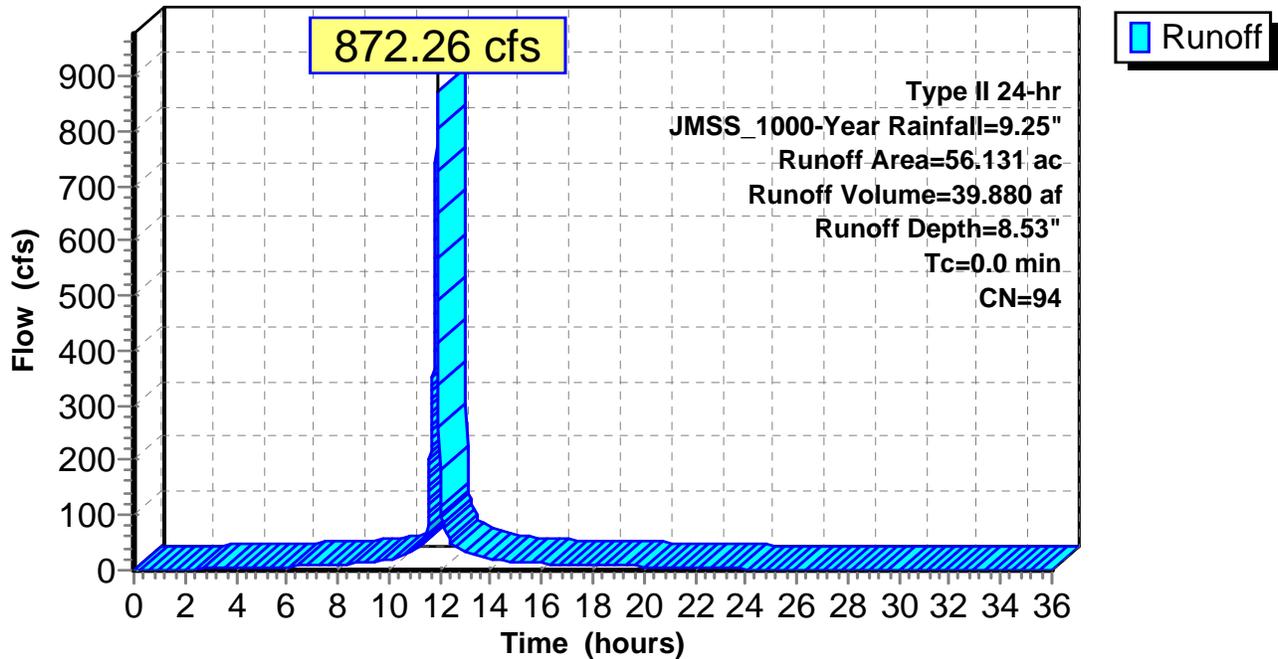
Subcatchment P3AS: Pond 3A Subcatchment

Hydrograph

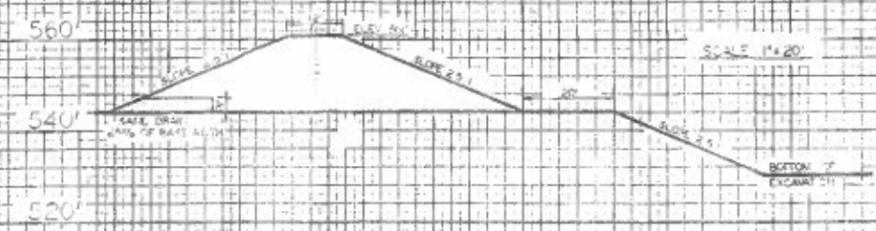
CROSS-SECTION OF PIT
FIG. VII-2A

- CLAY
- CLAY AND SAND
- SAND

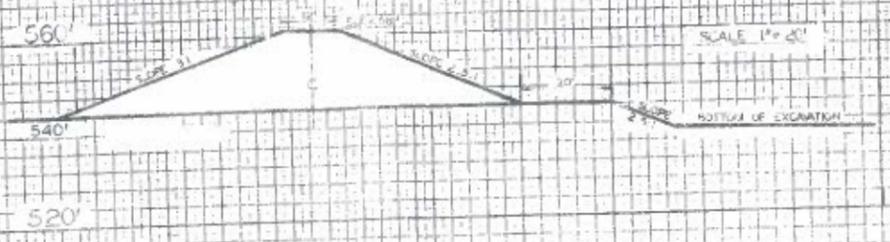
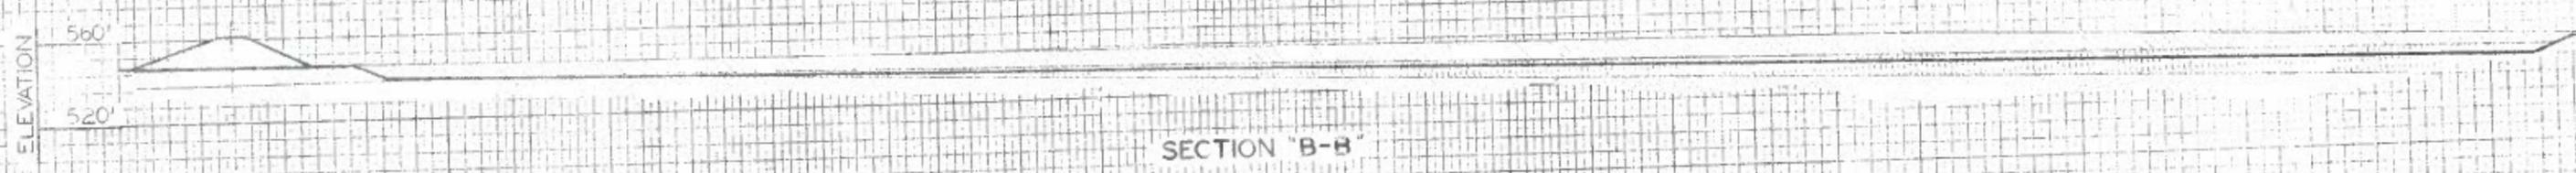
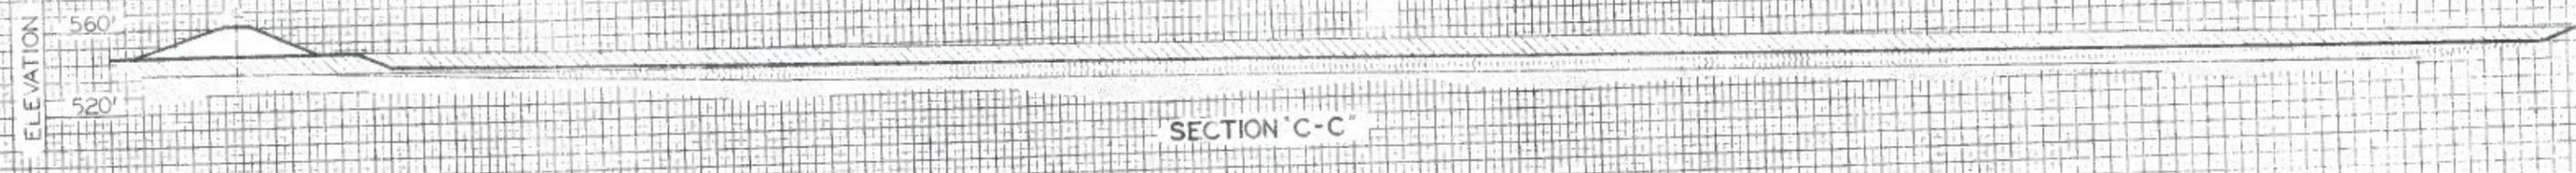
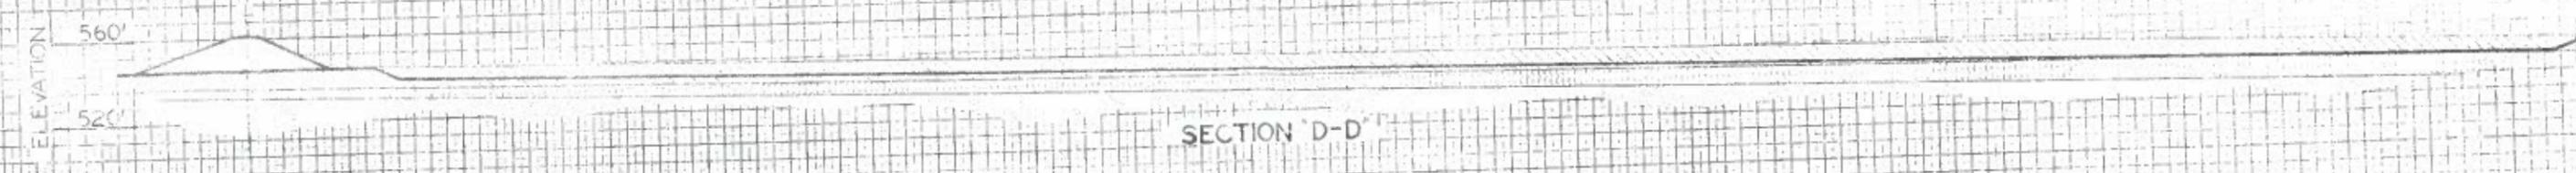
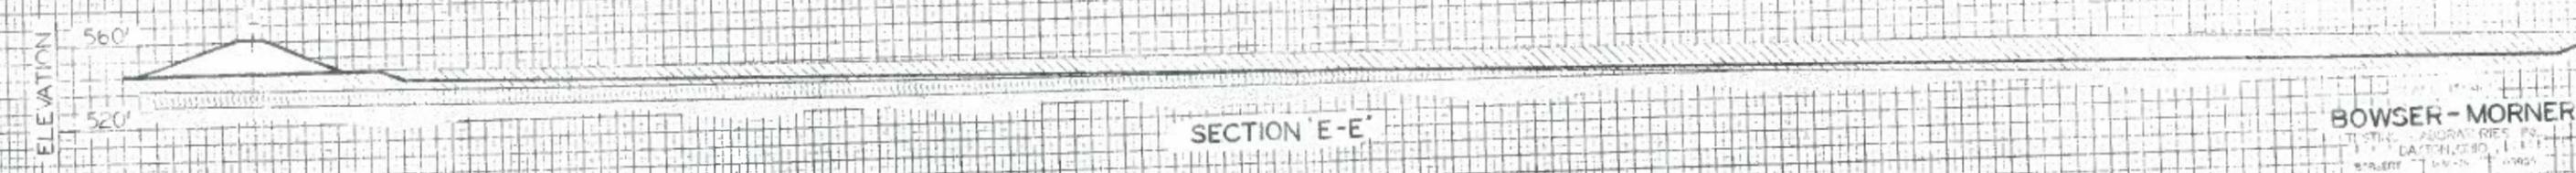
CROSS-SECTIONS OF PIT
FIG. VII-2B

2.5:1 INTERIOR SLOPE
3:1 EXTERIOR SLOPE
WITHOUT SAND DRAIN

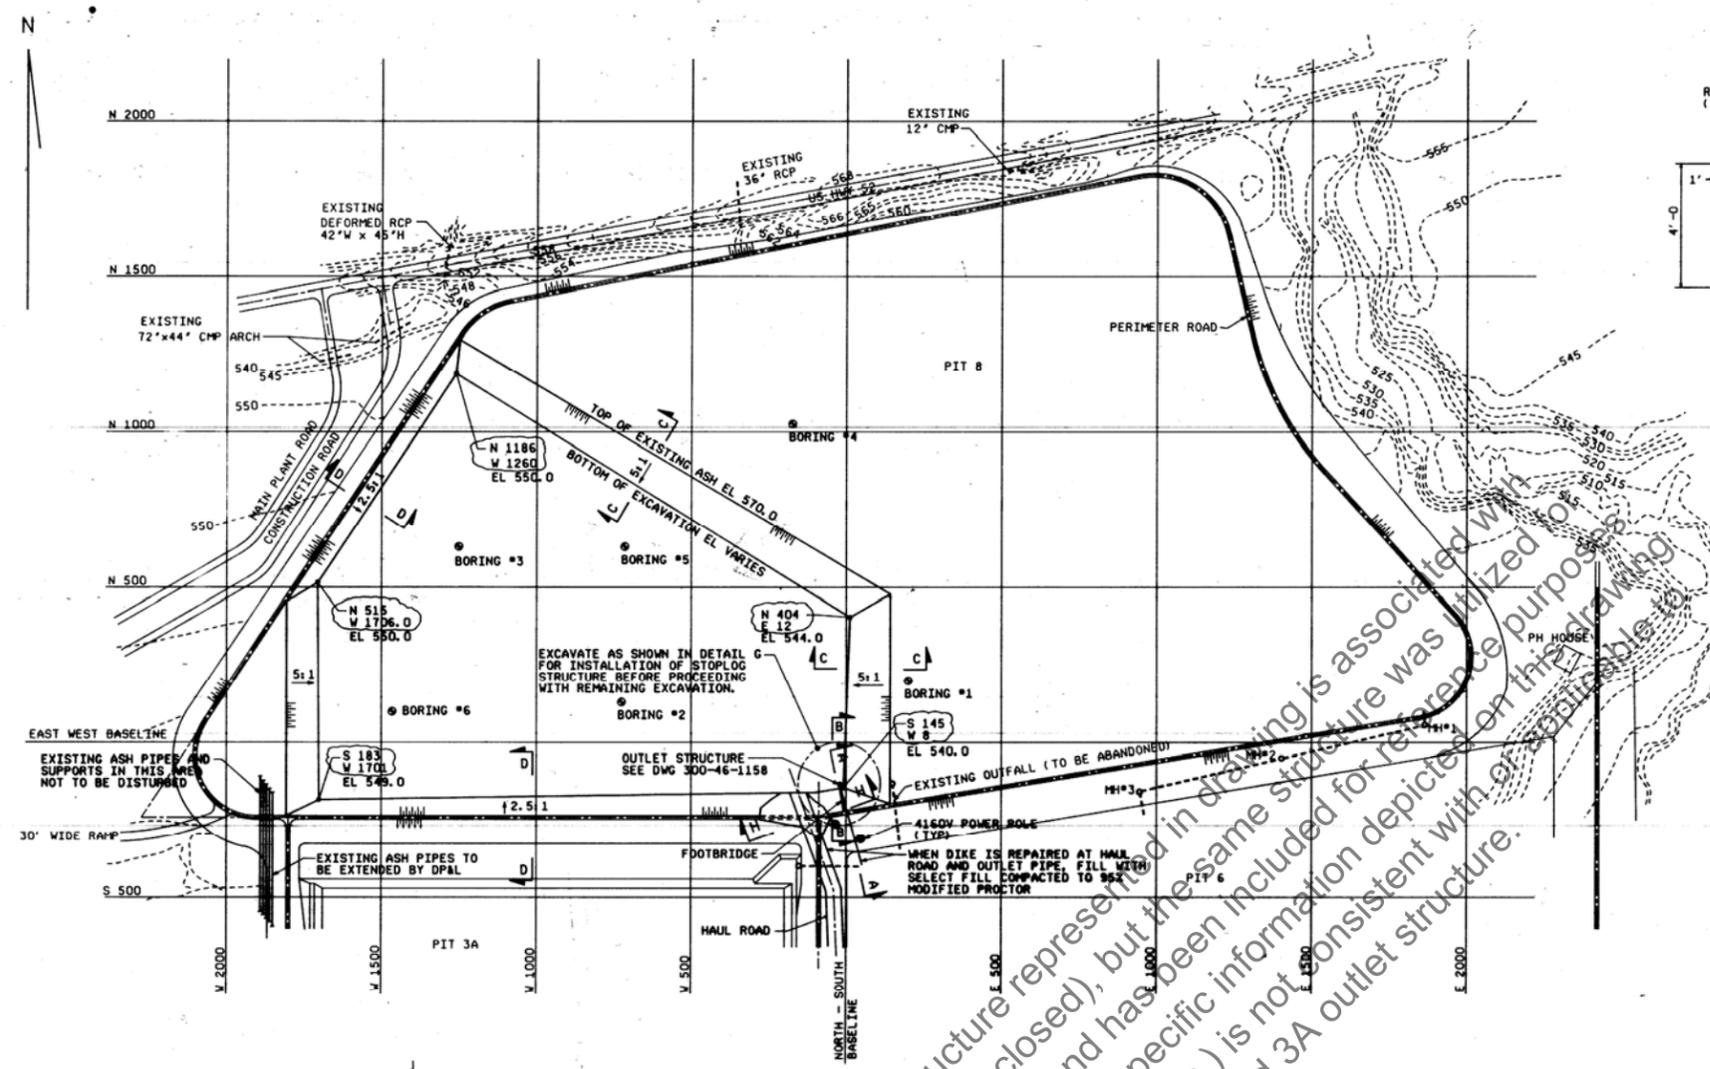
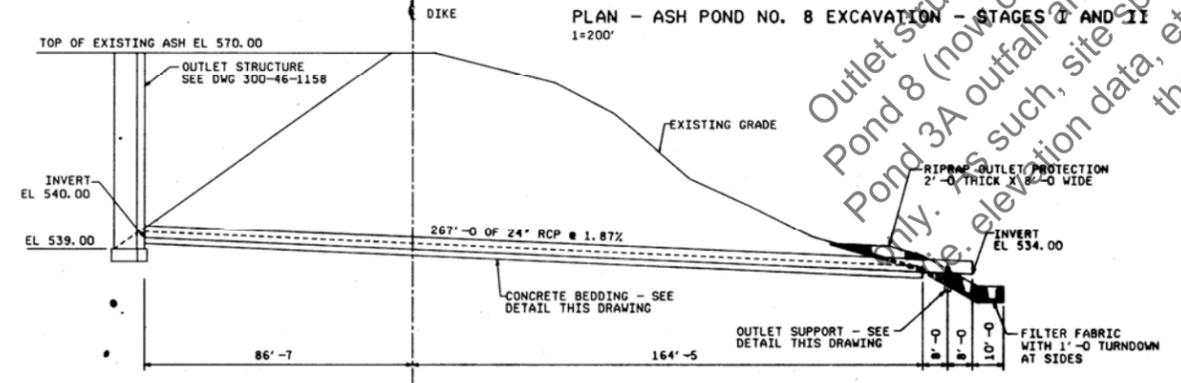
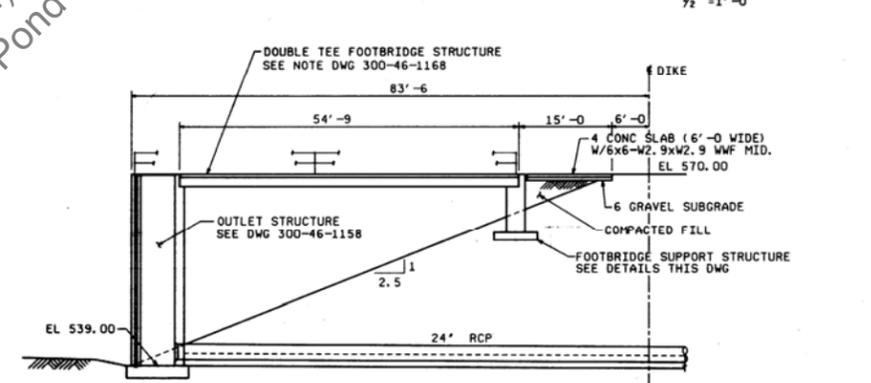
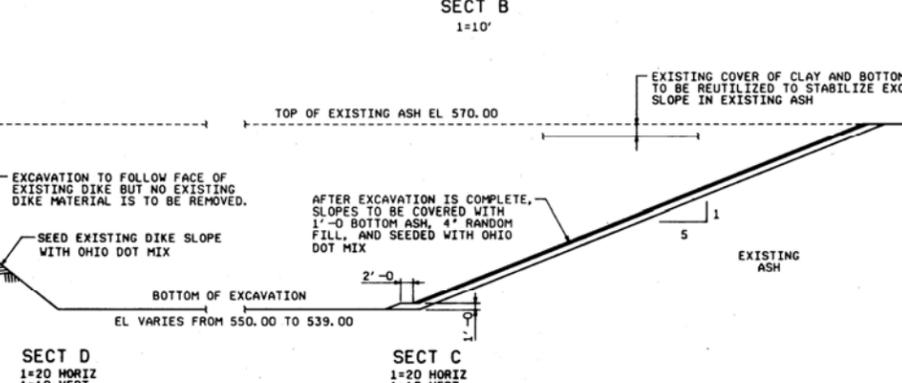
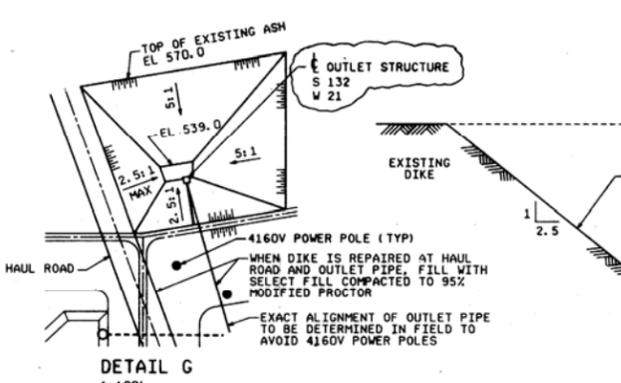
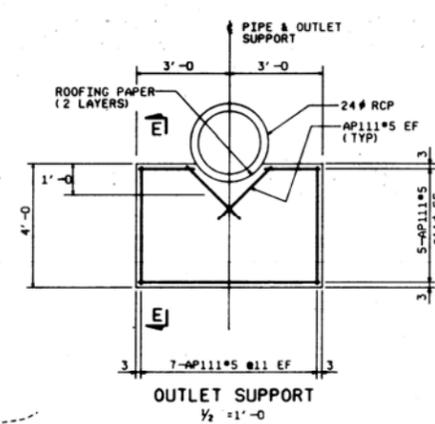
TITLE			
PLAN & SECTIONS ASH PITS 3A & B			
FOR			
J. M. STUART STATION			
SCALE	PROJECT	DATE	MAP SEC.
AS SHOWN	12/15/14	12/15/14	12/15/14
DRAWN	CHECKED	APPROVED	DATE
J. M. STUART	J. M. STUART	J. M. STUART	12/15/14
ENGINEER	APPROVED	DATE	FILE
J. M. STUART	J. M. STUART	12/15/14	300-12-1020C

Drawings 300-12-1020, -1022, and -1023 (1966) are related to construction of the Station, an ash pond west of the plant, and a coal storage area and ash disposal area east of the plant. The cross section on the 1966 drawings implies that the Station buildings are supported on pile foundations. The notes on the 1966 drawings provide the following information regarding construction of the dikes:

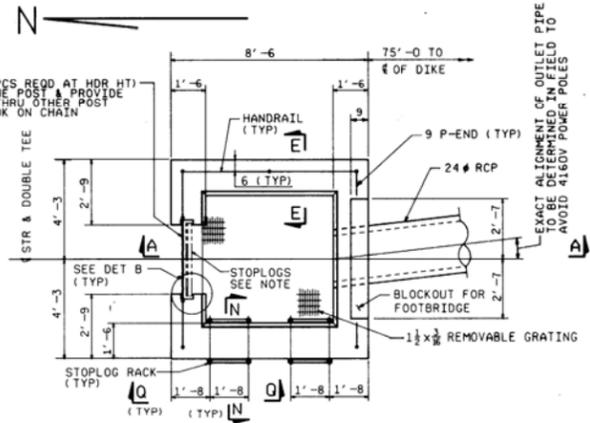
OUTLET STRUCTURE PLAN @ EL 570.00 - MAS

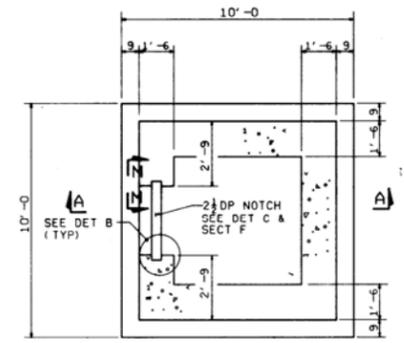
OUTLET STRUCTURE PLAN @ EL 539.00 - MAS

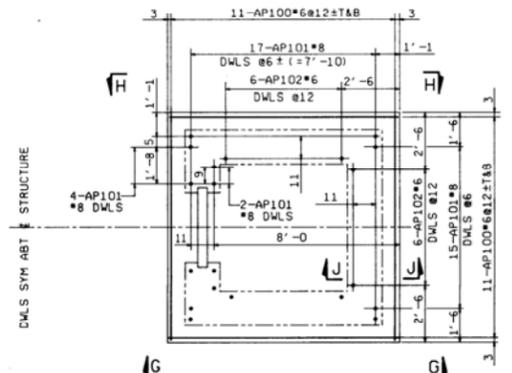
OUTLET STRUCTURE PLAN @ EL 539.00 - REINF
NOTE: CUT, SHIFT OR BEND DWLS AS REQUIRED FOR INSTALLATION OF 24# RCP.
