MEMORANDUM

SUBJECT: CCR History of Construction
Pond 6
Dayton Power & Light Company
J.M. Stuart Electric Generating Station
Aberdeen, Ohio

**Figure 1 and Appendix from:
Pond 6 Inflow Design Flood Control System Plan
By Haley & Aldrich, Dated October 2016**

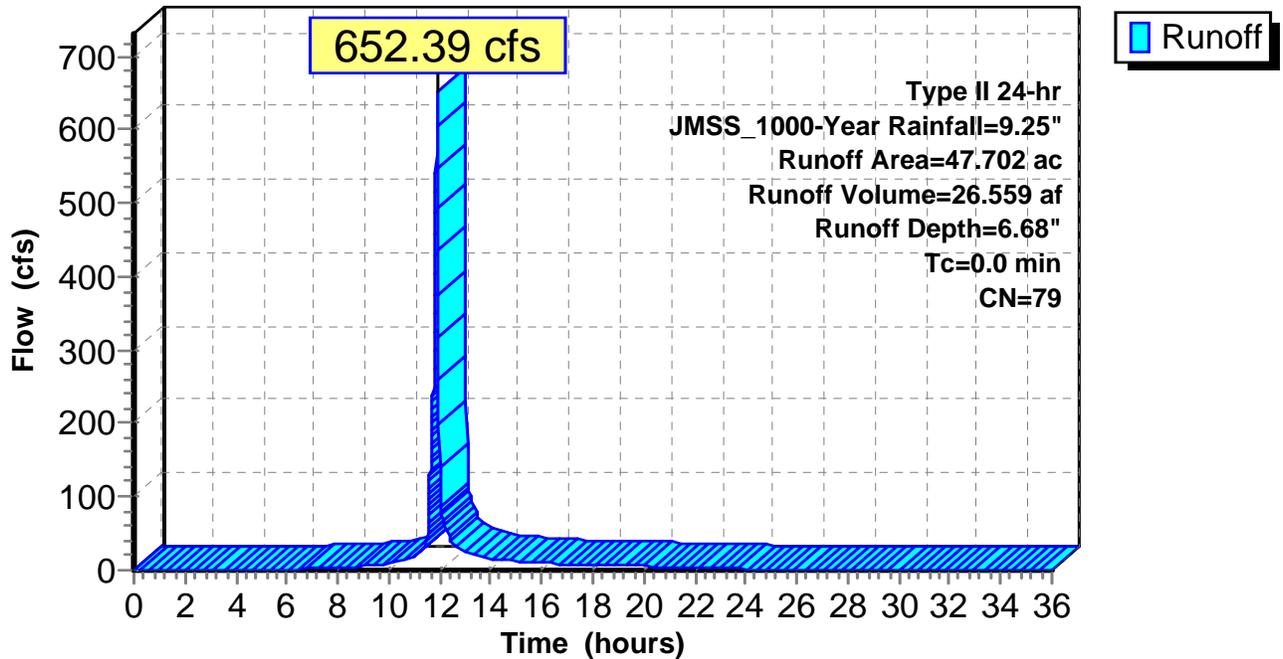
Subcatchment P6S: Pond 6 Subcatchment

Hydrograph

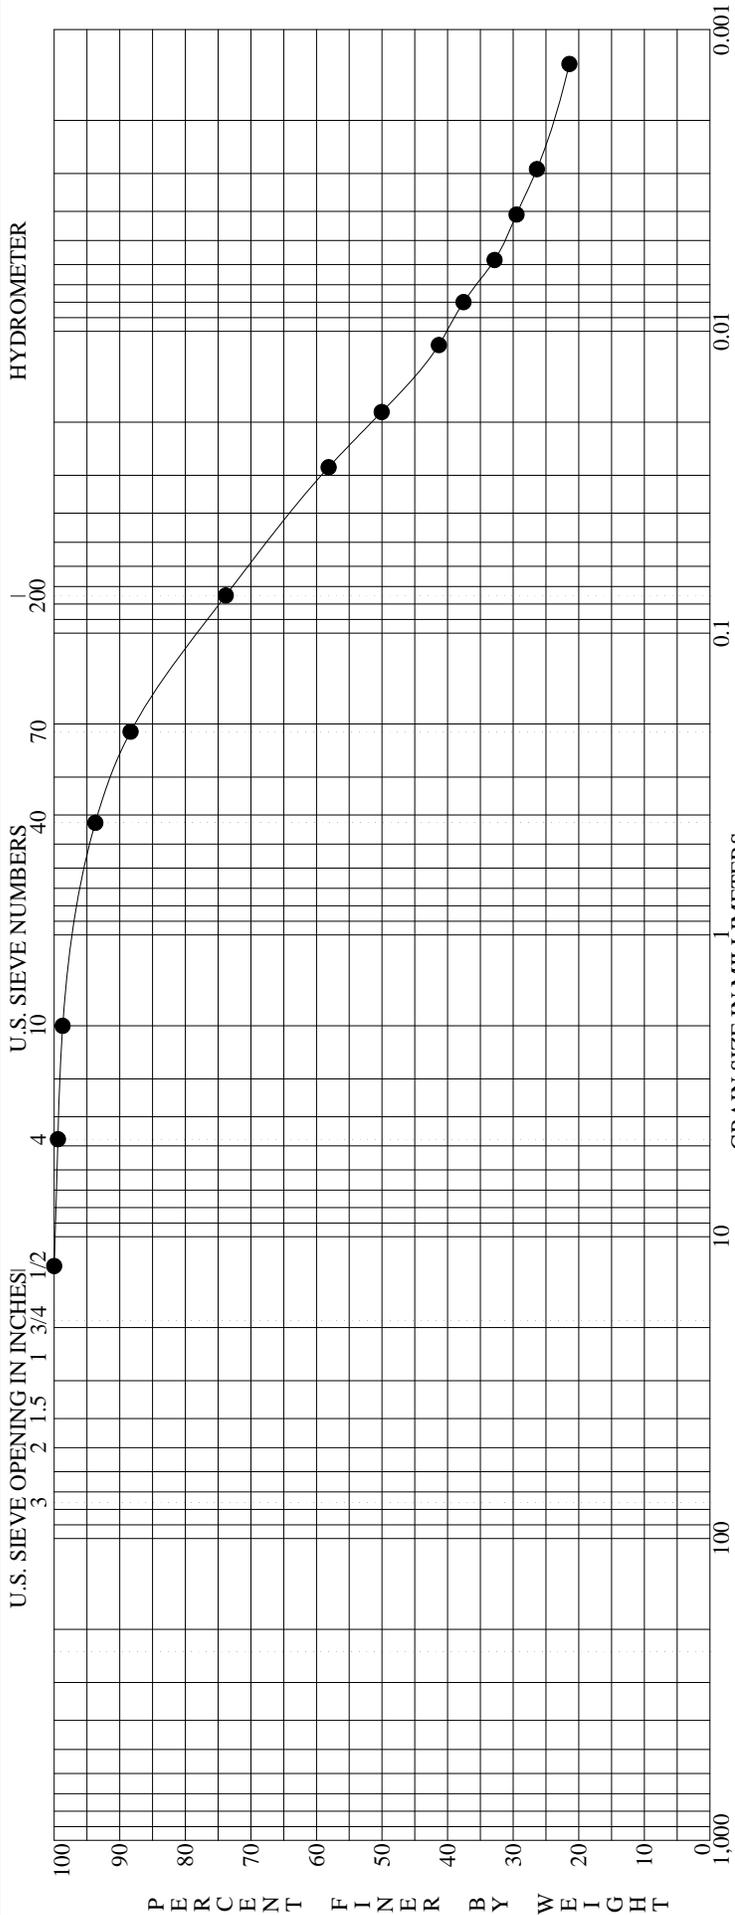
ASTM D422 **GRADATION CURVE** **PROJECT** PHASE 2 - STABILITY INVESTIGATION
LOCATION DP&L STUART STATION - ABERDEEN, OHIO
JOB NO. 011-12608-000 **DATE** 5/18/10

BOULDERS	COBBLES	GRAVEL			SAND			SILT OR CLAY				
		coarse	fine	medium	fine	medium	fine	MC%	LL	PL	PI	UWW
Specimen Identification - Depth ● B-6-1 S-10 28.5' to 29.4' FILL : Brown mottled with gray silty clay, some fine to coarse sand, trace fine gravel, contains wood fragments. ☒ ▲ ★ ○												
Specimen Identification - Depth ● B-6-1 S-10 28.5' to 29.4' 12.5000 0.6312 0.0316 0.0184 0.6 25.6 49.7 24.1												
LEAN CLAY with SAND CL

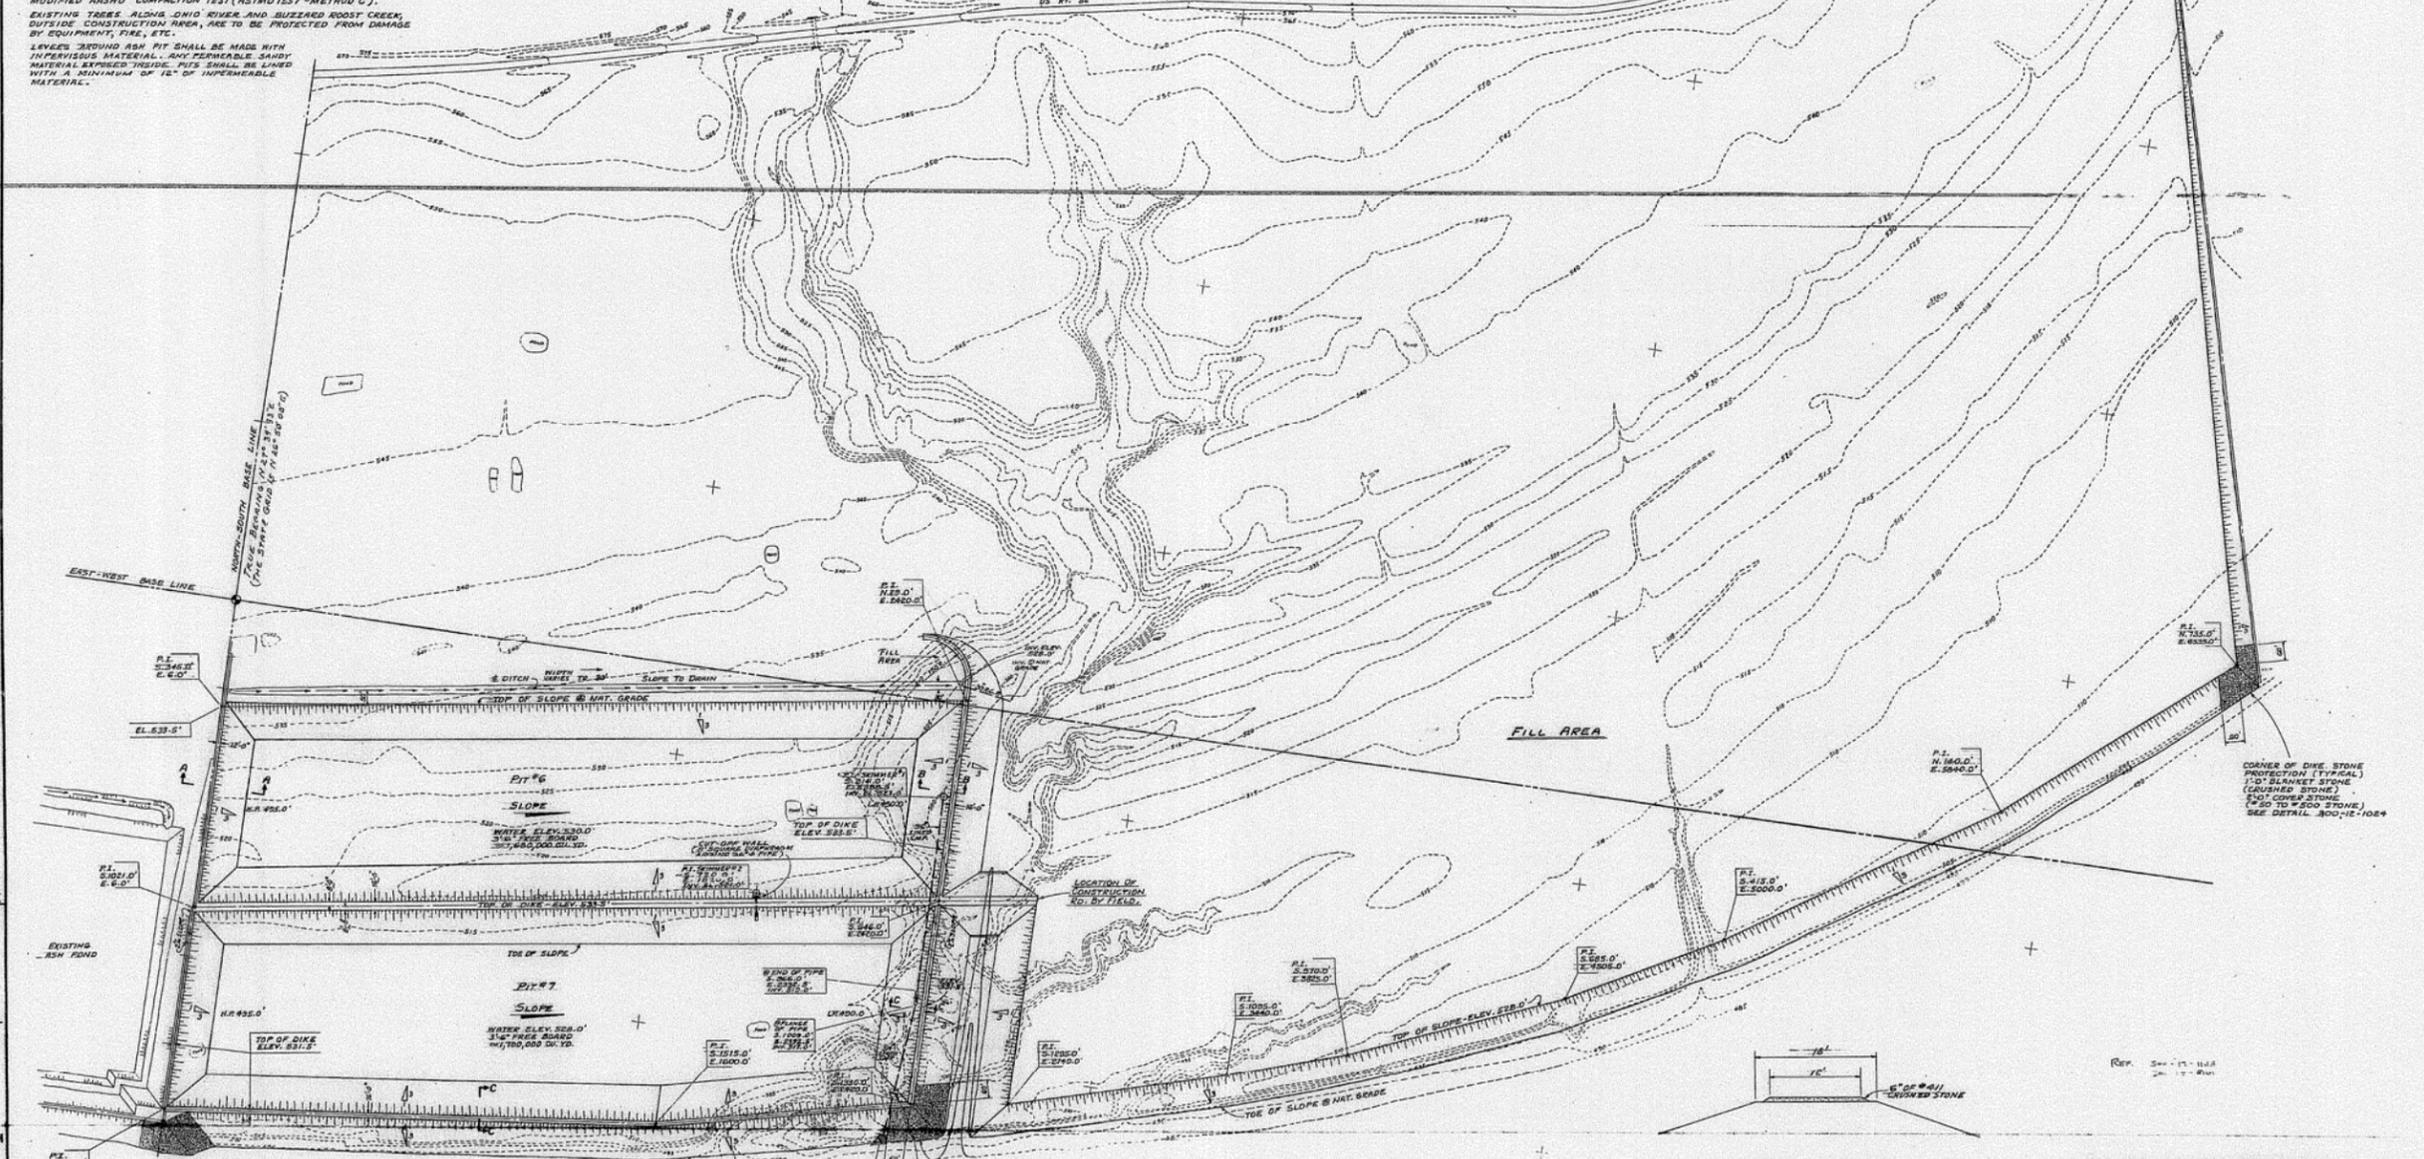
CORNER OF DIKE STONE PROTECTION (TYPICAL) 1'-0" BLANKET STONE (SQUARED STONE) 2'-0" COVER STONE (4'-0" TO 4'-6" STONE) SEE DETAIL 300-12-1020A

Drawings 300-12-1020, -1022, and -1023 (1966) are related to construction of the Station, an ash pond west of the plant, and a coal storage area and ash disposal area east of the plant. The cross section on the 1966 drawings implies that the Station buildings are supported on pile foundations. The notes on the 1966 drawings provide the following information regarding construction of the dikes:

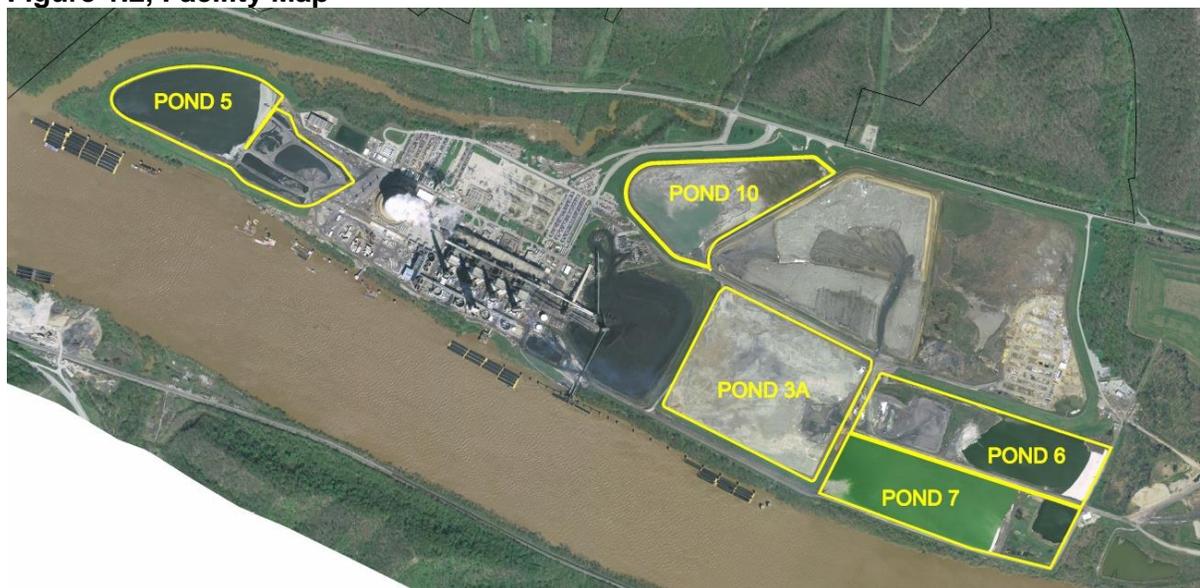
Figure 1.2, Facility Map

Ponds 3A, 7 and 10 are primary fly ash settling ponds. They receive ash sluiced from the fly ash collection system from the plant. Pond 6 receives water from plant sumps and ash sluice water from the above mentioned ponds. Under normal operation only one of the three ash sluice ponds will discharge water at any given time. Pond 5 is divided into two sections. The east section contains primary settling lagoons for bottom ash and other plant area drainage sumps.

DP&L has 5 impoundments located at the J.M. Stuart Station in Sprigg Township, Adams County, Ohio as shown on Figure 1.1, Location Map and Figure 1.2, Facility Map. The purpose of this manual is to increase the safety of the impoundments by defining the procedures for operating, maintaining and inspecting the dams on a regular basis. The facility's characteristics are shown in Section 1.2's tables. The Operation, Maintenance & Inspection Manual (OM&I Manual) was prepared as required by OAC 1501:21-15-06.
