9.0 MALFUNCTIONS AND ACCIDENTS

9.1 Identification of Malfunctions and Accidents

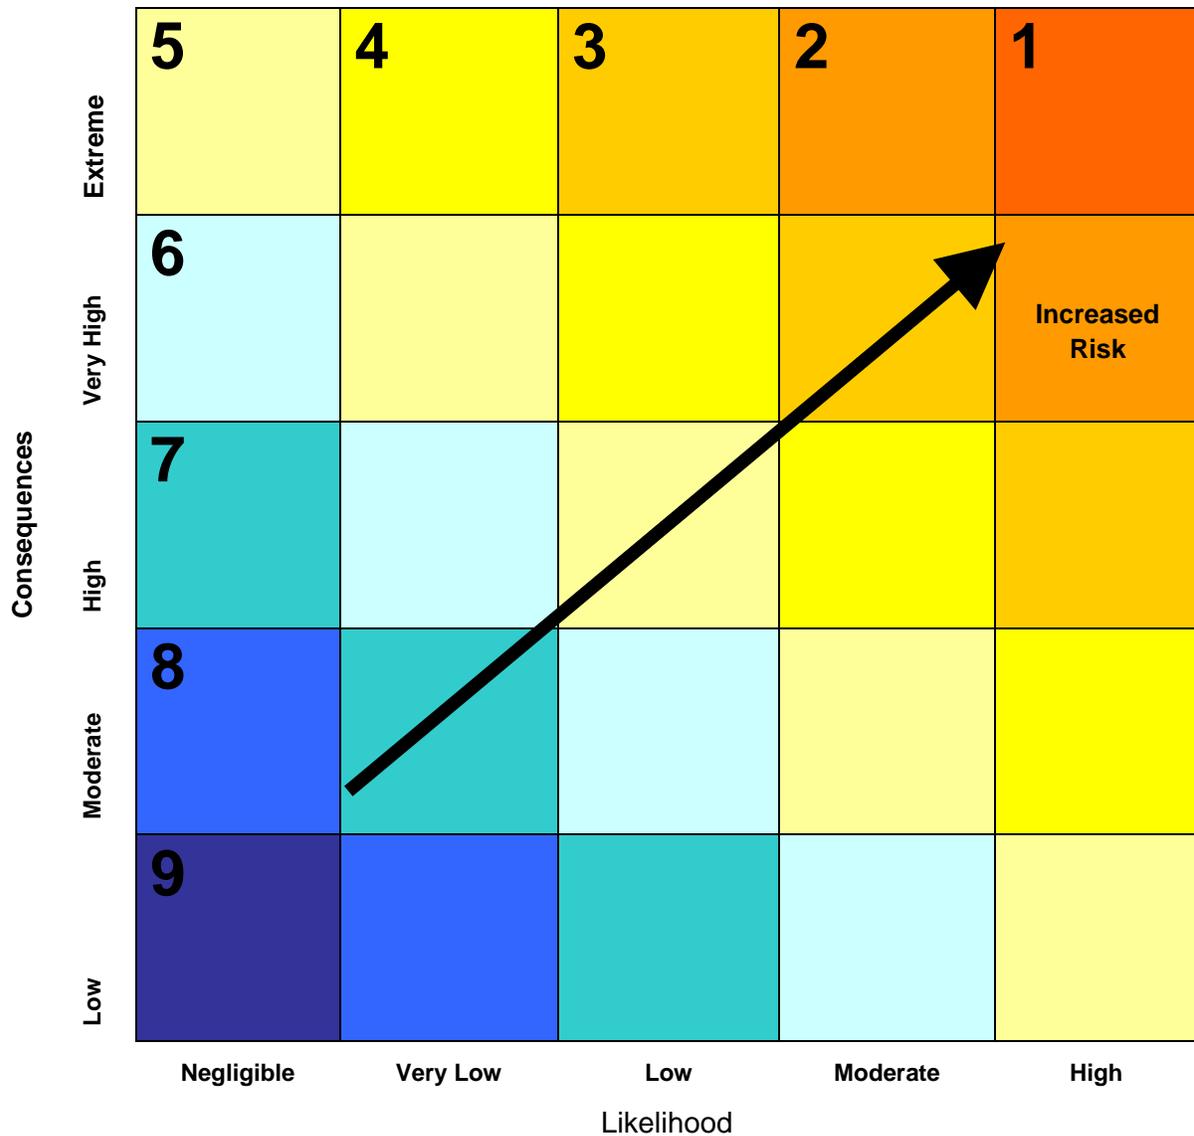
Figure 9-1: Environmental Risk Matrix

Each credible potential accident and malfunction discussed above was assessed according to likelihood of occurrence and magnitude / consequence of occurrence, and given a risk ranking of between 1 (highest) and 9 (lowest). Each risk ranking refers to a diagonal row of cells within a risk matrix shown in the same colour (Figure 9-1). As shown in the risk matrix, increased risk is associated with malfunctions and accidents having a greater likelihood of occurrence and increased level of consequence, as is intuitively true.
