Tailings Stewardship and Facilities Overview

Our Approach to Tailings Management

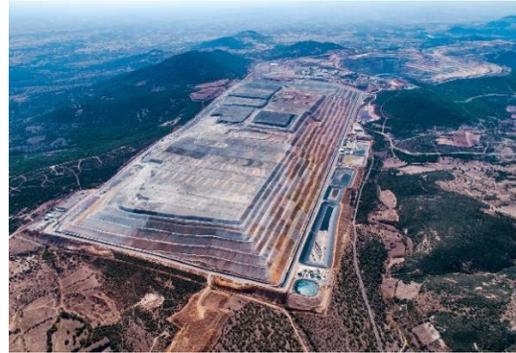
At Kışladağ, we crush and stack dry ore in a contained facility. A water-based solution is irrigated through the ore in order to separate gold from the surrounding rock. As all of the water that enters the ore is removed or evaporates, the material remains dry and stable. No tailings are produced using this method.

The Kışladağ Leach Pad, Turkey

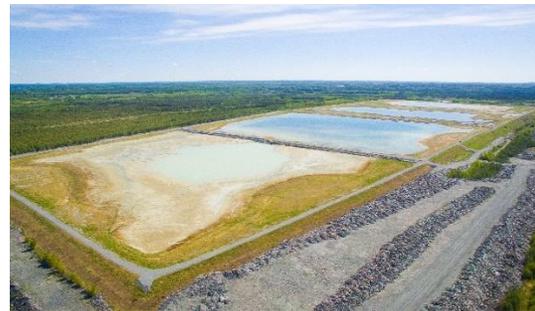
Rock Buttreassing at the Sigma Tailings Storage Facility, Canada

Lamaque <i>Quebec, Canada</i>	Sigma Tailings Storage Facility	Slurried	Upstream embankments with reinforced rock buttressing	High	Current volume: 765,000m ³ Max height: 18.5m	4 dykes; 4 internal basins	Wood	2018	Yes	Active
Vila Nova <i>Amapa State, Brazil</i>	Vila Nova Tailings Dam	Slurried	Downstream	Significant	Current volume: 288,500m ³ Max height: 16.4m	1 dam	TEC3	2018	Yes	Inactive; on care and maintenance

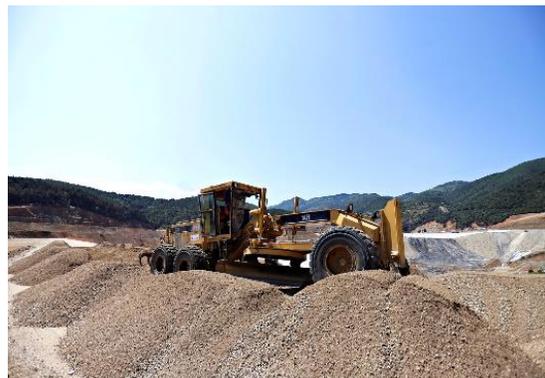
Dry-stack tailings are produced by passing a slurried tailings mixture through filter presses. These presses remove excess water from tailings. The output is a sand-like material that is then stacked and compressed.

Dry-stack tailings at the Kokkinolakkas Tailings Management Facility, Greece
