Tailings Stewardship and Facilities Overview

Our Approach to Tailings Management

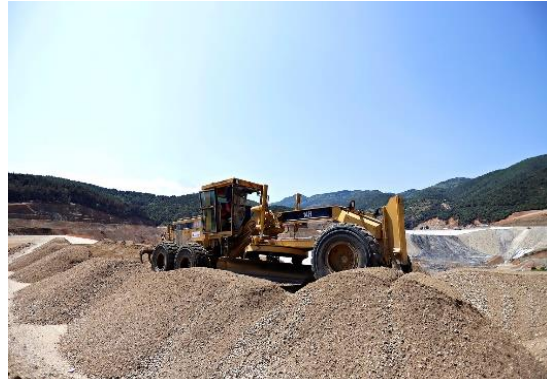
Dry-stack tailings are produced by passing a slurried tailings mixture through filter presses. These presses remove excess water from tailings. The output is a sand-like material that is then stacked and compressed.

Dry-stack tailings at the Kokkinolakkas Tailings Management Facility, Greece

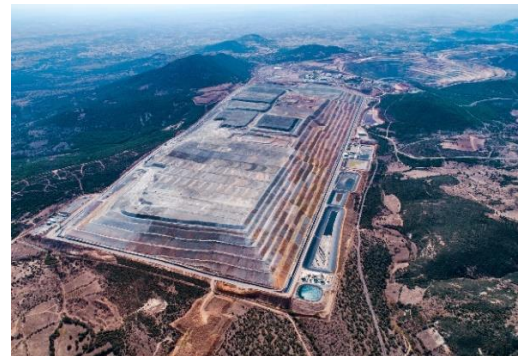
At Kışladağ, we crush and stack dry ore in a contained facility. A water-based solution is irrigated through the ore in order to separate gold from the surrounding rock. As all of the water that enters the ore is removed or evaporates, the material remains dry and stable. No tailings are produced using this method.

The Kışladağ Leach Pad, Turkey

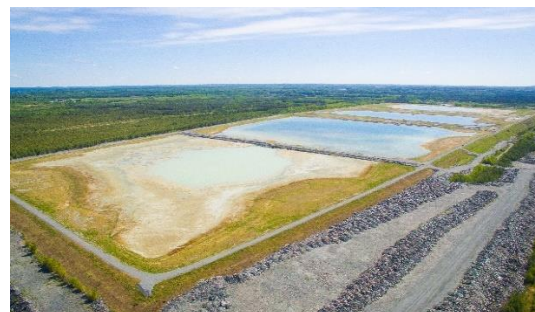
Rock Buttreassing at the Sigma Tailings Storage Facility, Canada

Eldorado has acquired two tailings facilities: the Sigma Tailings Facility and the Lamaque Closed Tailings Facility at Lamaque. The Sigma Tailings Facility has been redesigned and improved in accordance with these criteria to mitigate impacts and risks. The Lamaque Closed Tailings Facility has not operated since 1989 and is subject to monitoring and review.

Lamaque <i>Quebec, Canada</i>	Sigma Tailings Storage Facility	Slurried	Active	Upstream embankments reinforced with rock buttressing	High	Current volume: 765,000m ³ Max height: 18.5m	4 dykes; 4 internal basins	Wood	2019	Yes
Lamaque <i>Quebec, Canada</i>	Lamaque Closed Tailings Facility	Slurried	Closed Inactive since 1989	Upstream	High	Current volume: ⁶ 16M m ³ Max height: 10m	4 dykes; 1 internal road	Golder	2019	No
Vila Nova <i>Amapa State, Brazil</i>	Vila Nova Tailings Dam	Slurried	Inactive; on care and maintenance	Downstream	Significant	Current volume: 288,500m ³ Max height: 16.4m	1 dam	TEC3	2020	Yes
